Manhole Inspection Summary

Manhole # S43CC_017MH

Location Address: **834 n bond st**

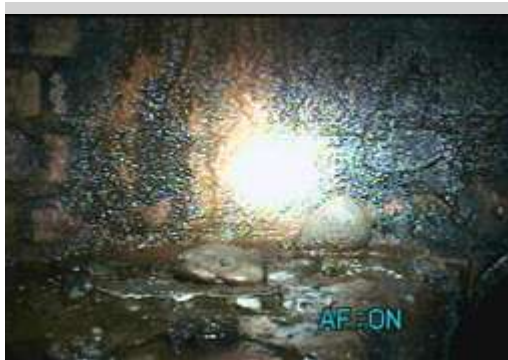
Misc

bench debris

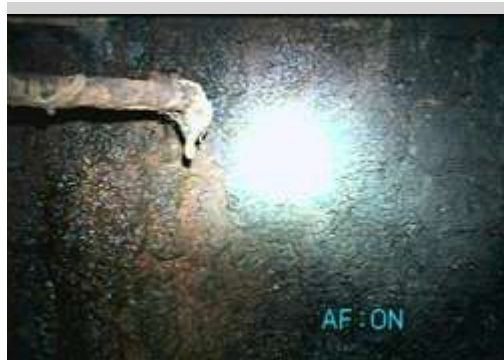
Defect 4

Infiltration: ☐ None ☐ Joint ☐ Cracks ☐ Mortar ☐ Roots ☒ **Wall**

barrel infiltration at wall

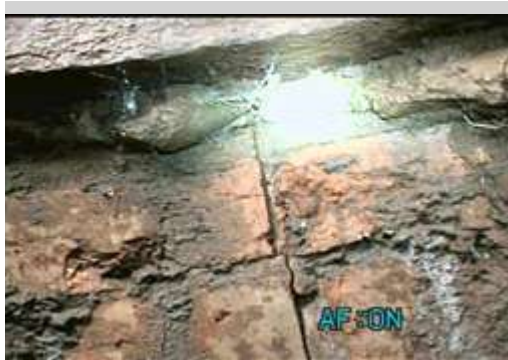
Defect 3

Condition: ☐ Sound ☒ **Cracked** ☐ Root Intrusion ☐ Loose Brick ☒ **Deteriorated**

chimney cracked deteriorated at frame joint and wall

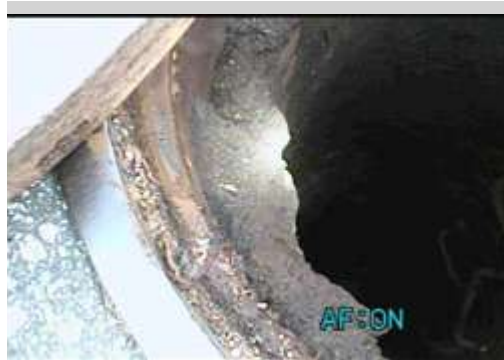
Defect 2

Offset: **2** (in.)

frame offset 2 inches

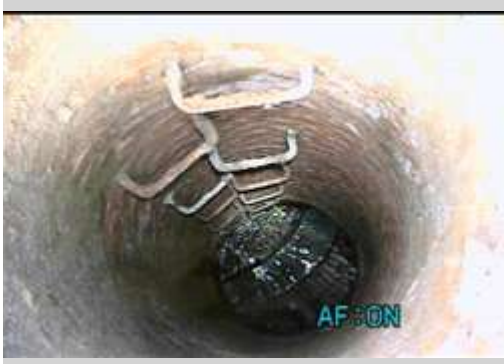
Defect 1

Count: **11** Missing: **0** ☒ **Corroded**

steps corroded
